HP® LASERJET 1160 • 1320 CARTRIDGE REMANUFACTURING INSTRUCTIONS

REMANUFACTURING THE HP LASERJET 1160/1320 TONER CARTRIDGE

By Mike Josiah

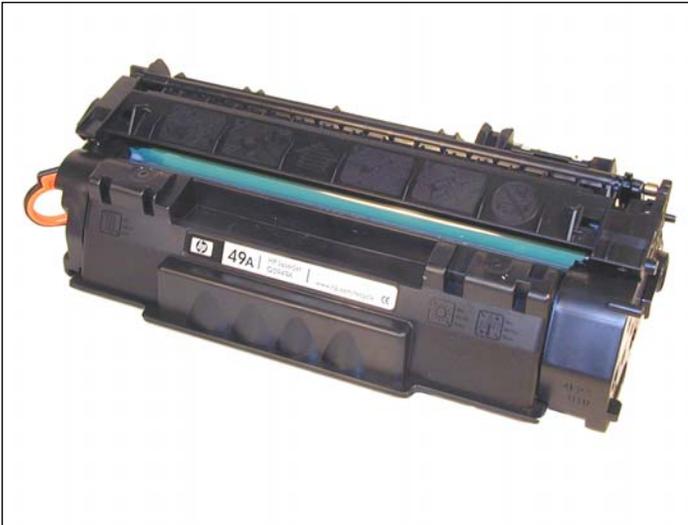
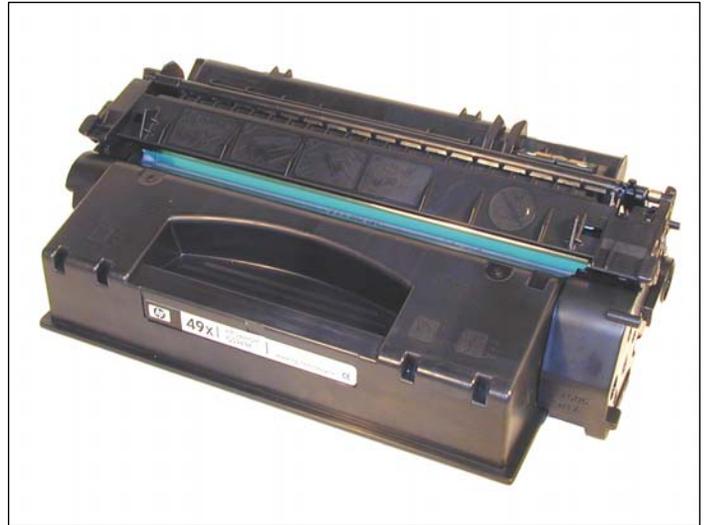
First introduced in September 2004, HP-1160/1320 series of laser printers is based on 20-22 ppm, 1200dpi Canon engine that comes standard with 16MB memory. The fuser is of the instant-on variety and along with a new processor it prints the first page out in less than 8.5 seconds (that is actually 0.5 seconds slower than the 1300). Two different cartridges are available for the 1320, the Q5949A rated at 2,500 pages, and the Q5949X rated for 6,000 pages. For the 1160, only the Q5949A cartridge will fit. Shown are the different physical sizes of the two cartridges:

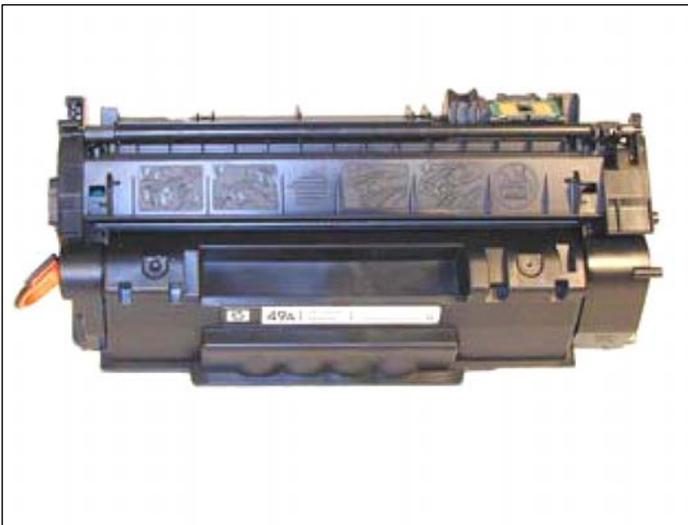
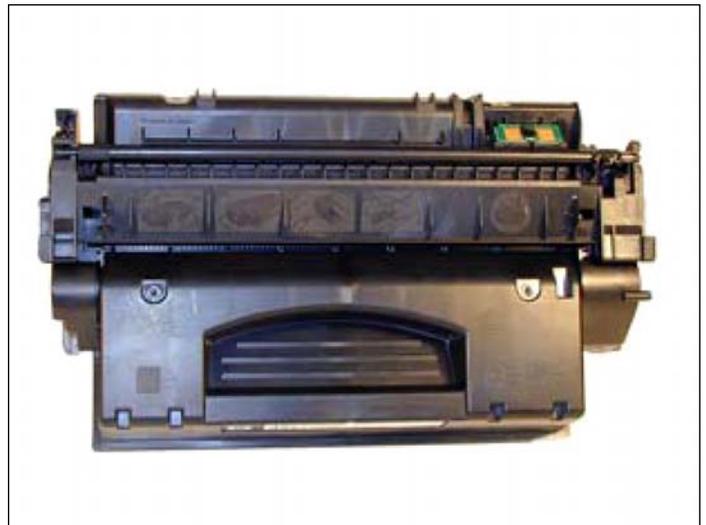
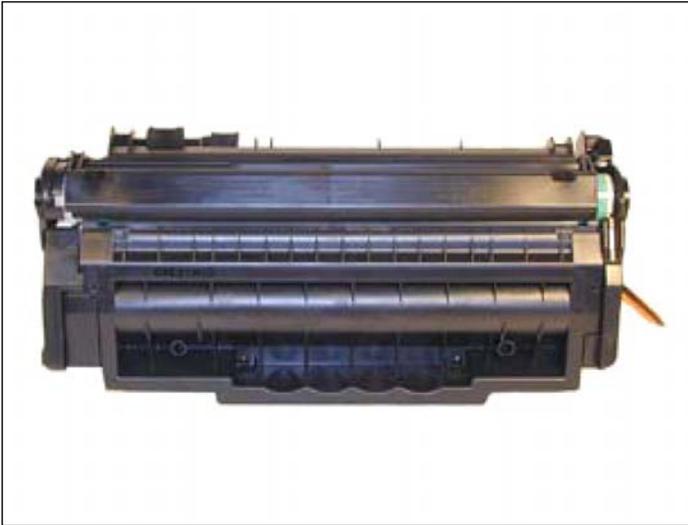
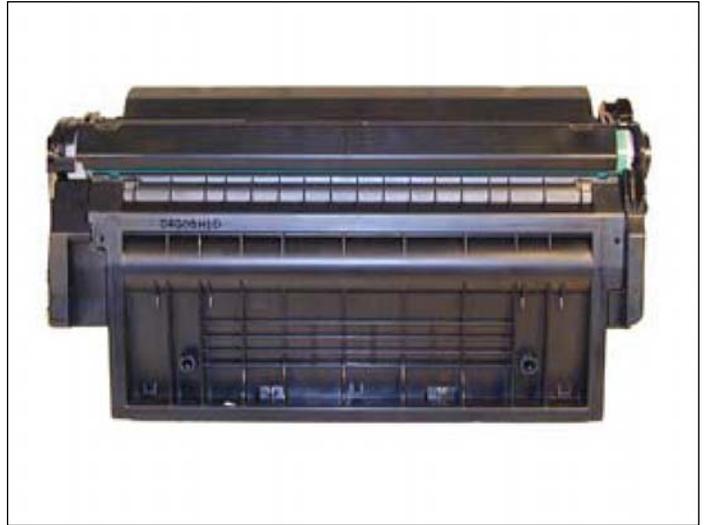
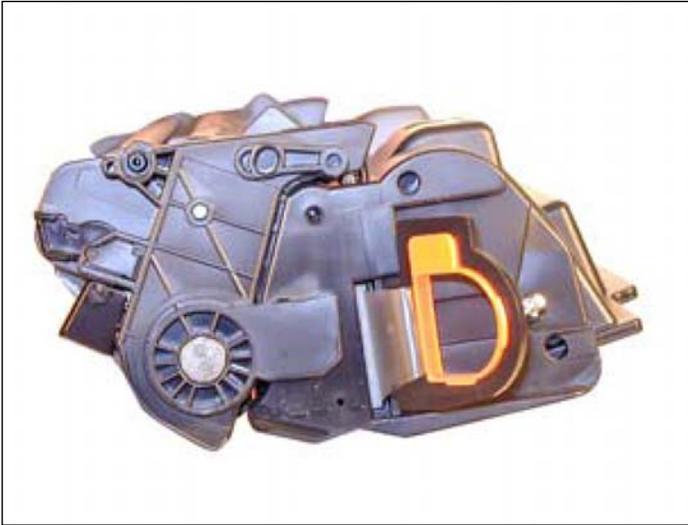
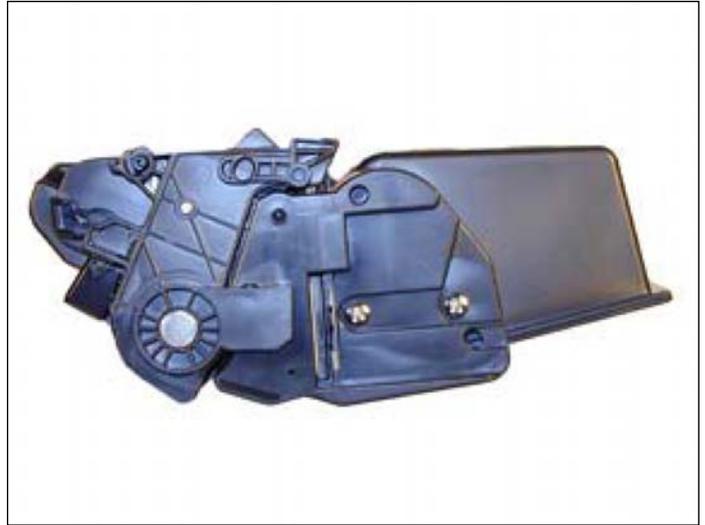
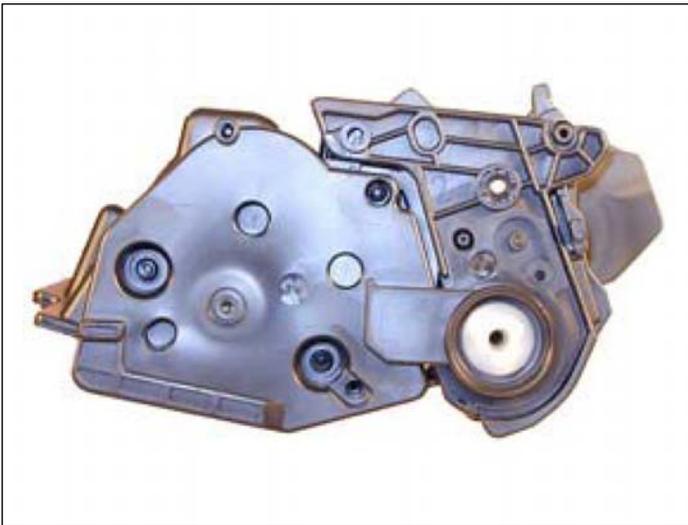
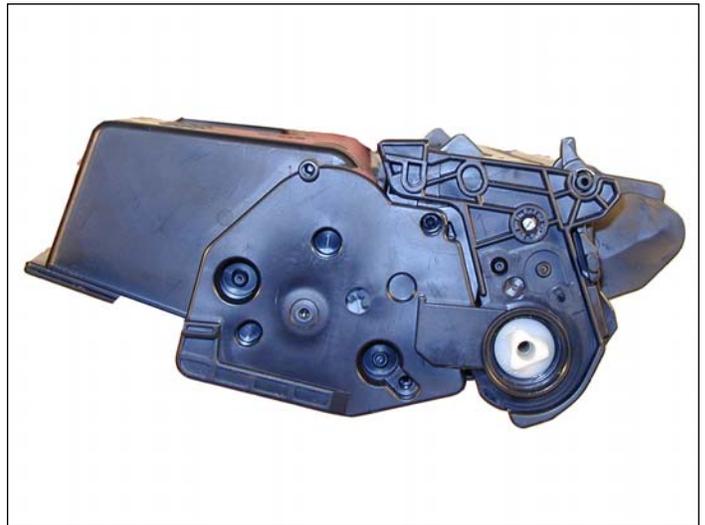
Spec wise, the old 1300 series is very similar to these new printers. The 1160 and 1320 actually have a 0.5 seconds slower first page out speed! The biggest difference in these machines is that these newer models have wireless modems built in, a nice touch. My main complaint with the 1200/1300 series was always the flimsy paper trays. These machines have an internal, more robust paper tray that should hold up much better than the old design. For that change alone, I like these machines. The cartridges are similar in design to the 1200/1300 cartridges, but are not interchangeable. Shown below and in the following page are the physical cosmetic cartridge differences.

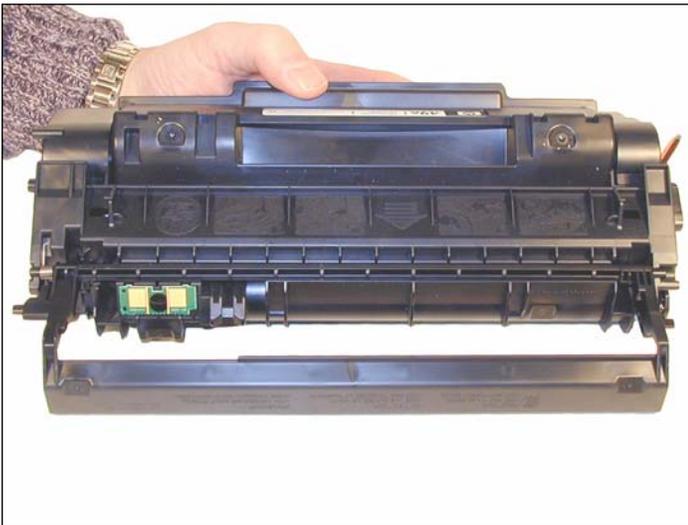
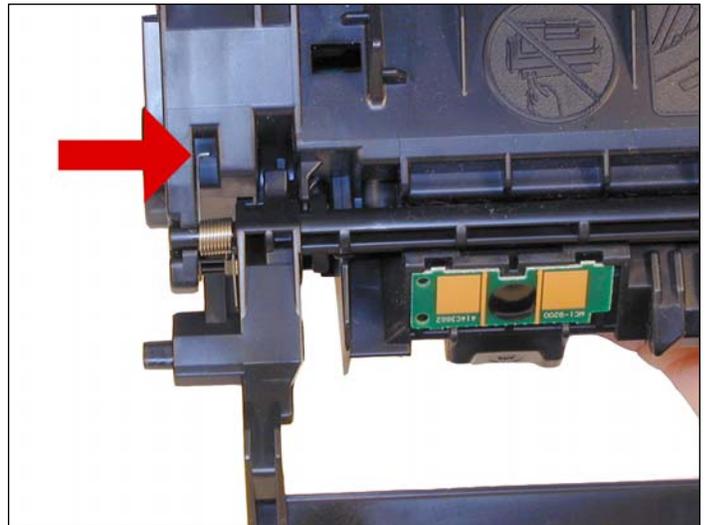
1. Remove the drum cover by prying up on each end. Note the spring position so that it can be replaced later.

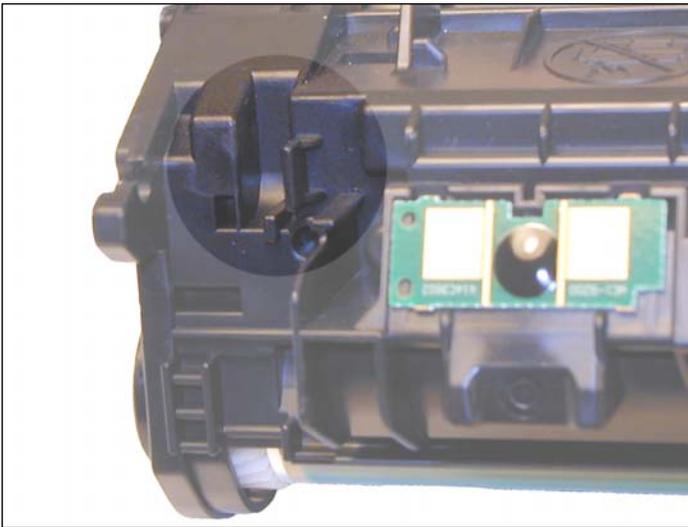
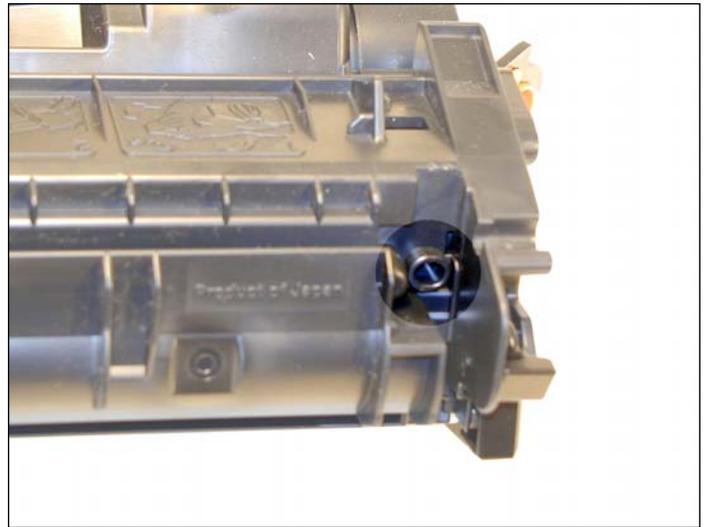
2. Drill a shallow hole on each side of the cartridge as indicated: **Holes uncut.**

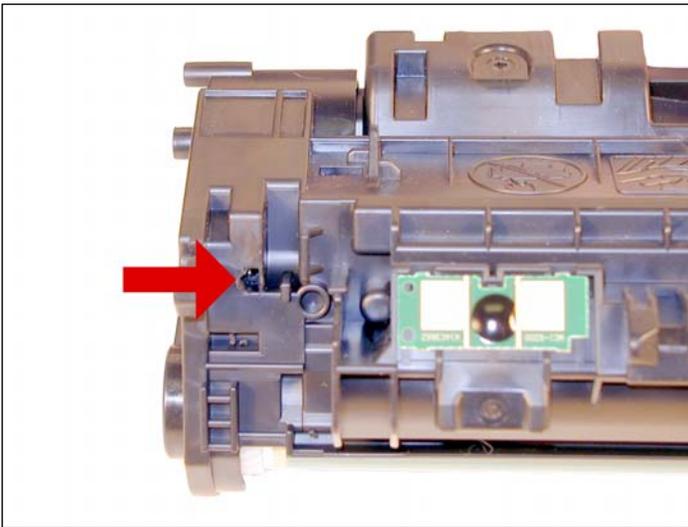
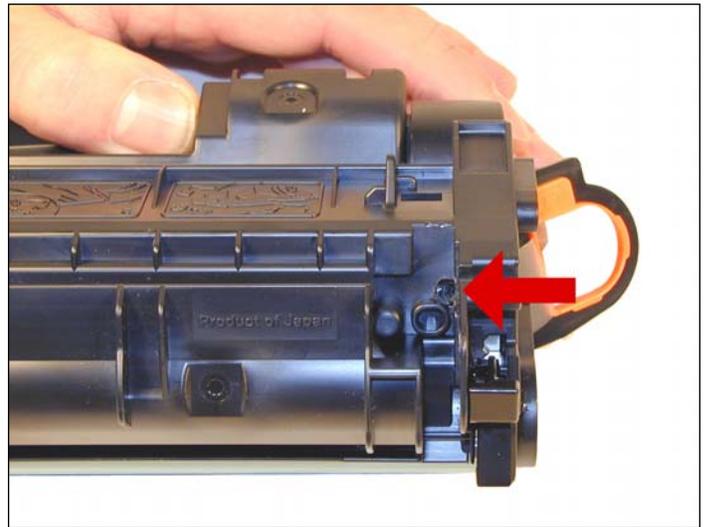
Holes cut.

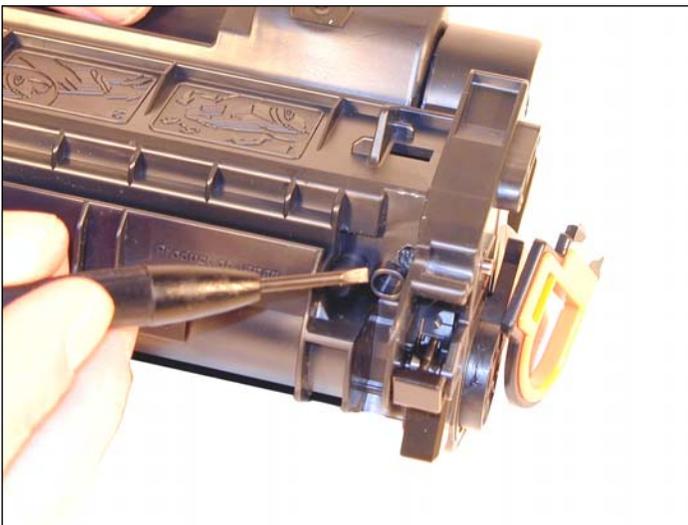
3. Push the pins out with a jeweler's screwdriver. With the hole in this location by just pushing the screwdriver in, the pins will be pushed out. Remove the pins.

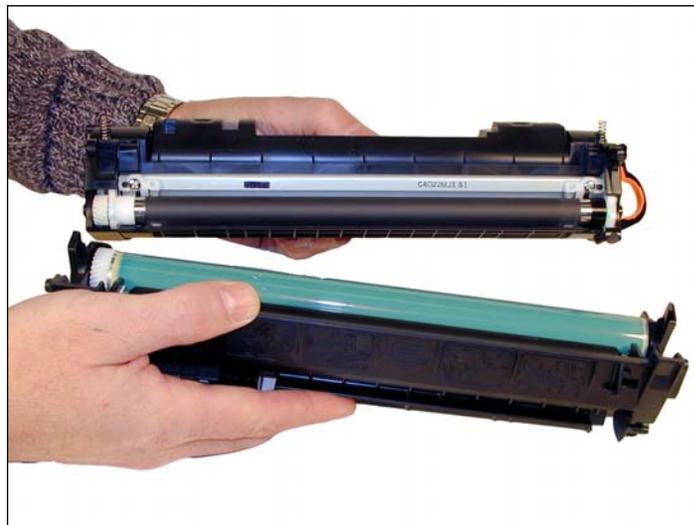
4. Separate the two halves.

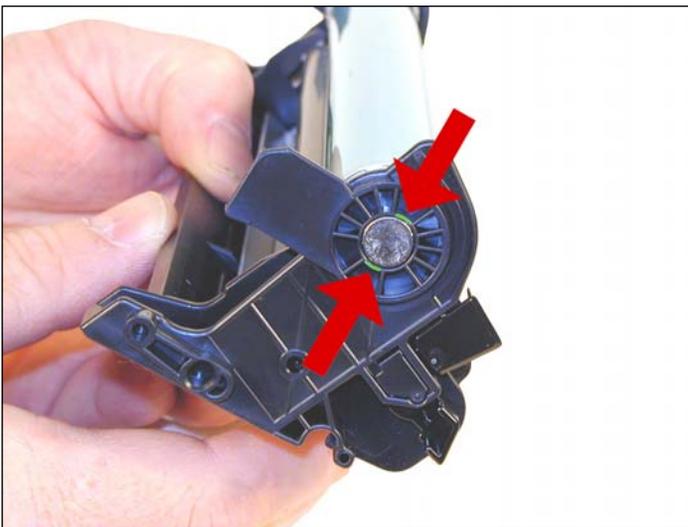
5. Cut two small pieces of plastic out from the hub surrounding the metal axle pin. Cut them on the opposite side of each other. This way you can pry the pin out with a small jeweler's screwdriver, and flush cutting wire cutters.

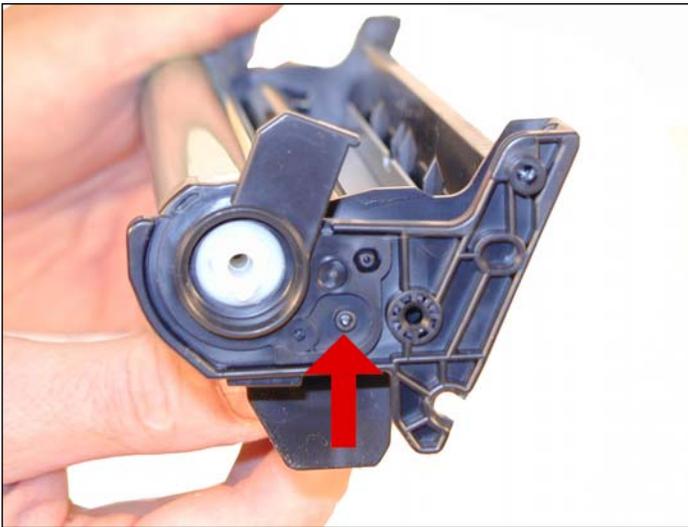
6. The drum hub that on earlier cartridges would have been removed is now welded. The weld can be broken or drilled out, but there is a good chance that the hub will either warp if pried off, or will be hard to align if drilled out.

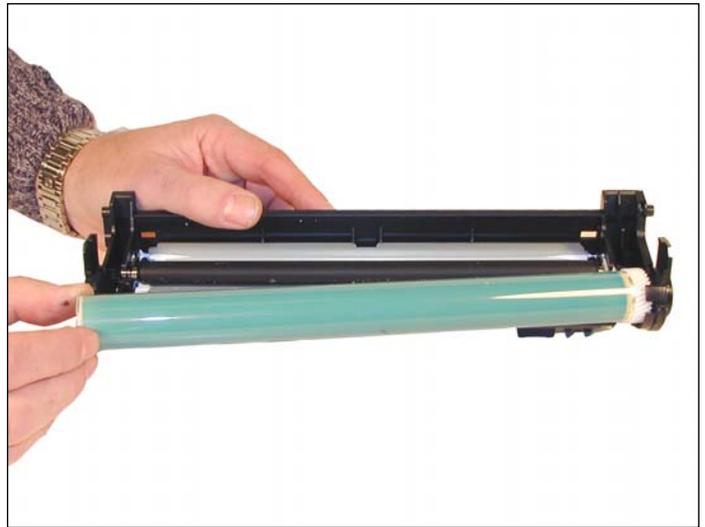
7. Remove the drum.

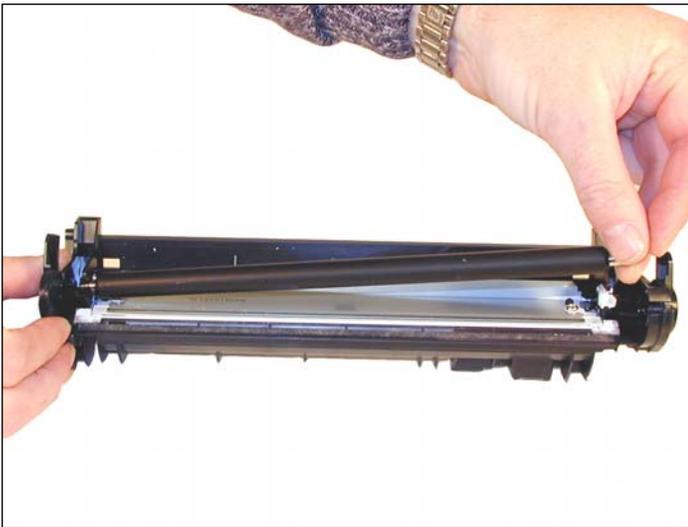
8. Remove the PCR and clean with your standard PCR cleaner. We have been using Nu-Finish for years with out any problems.

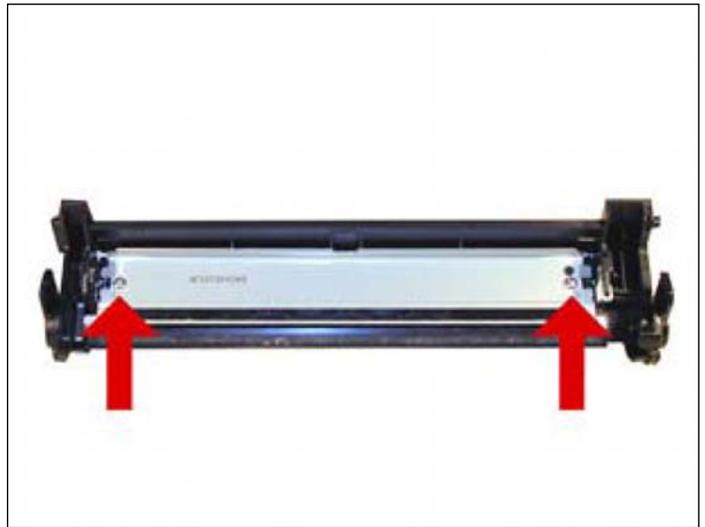
9. Remove the wiper blade. The blade is the same as used in the HP 1200. Clean out the waste toner.

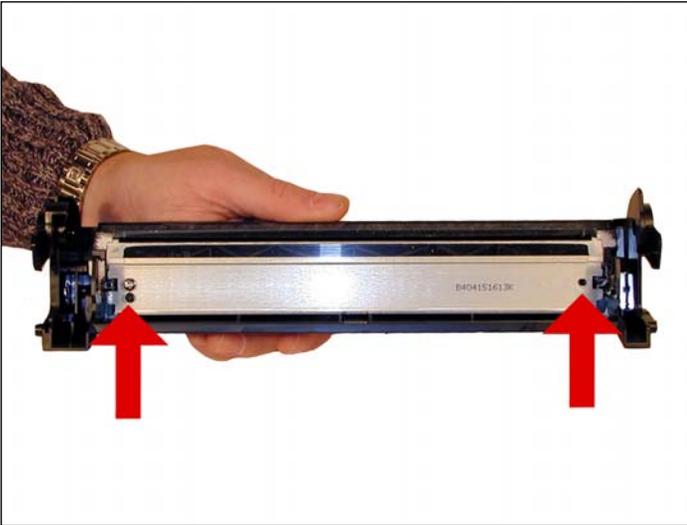
10. Coat the wiper blade with your preferred lubricant and install.

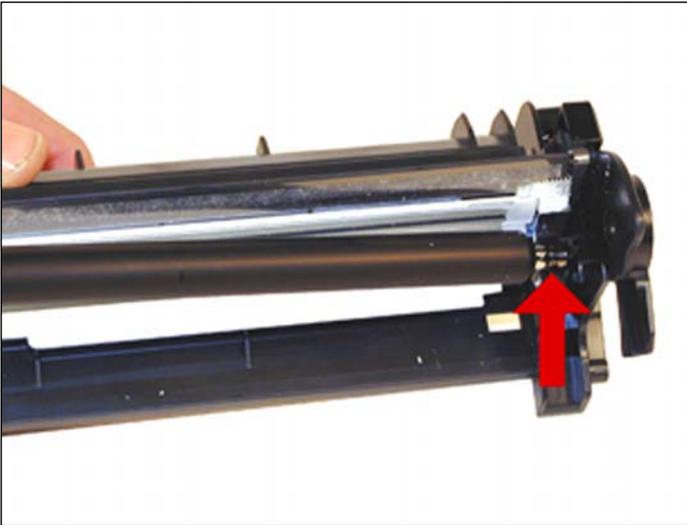
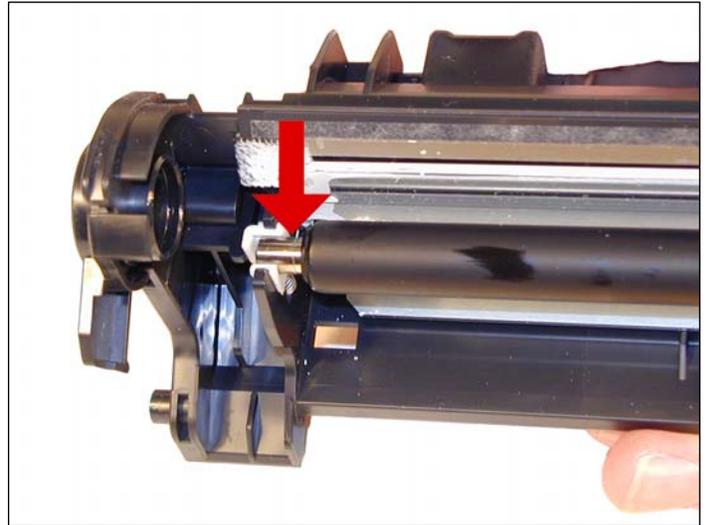
11. Re-install the cleaned PCR. Note that a new OEM PCR has a small amount of conductive grease on the black (contact) side and what appears to be white lithium grease on the other.

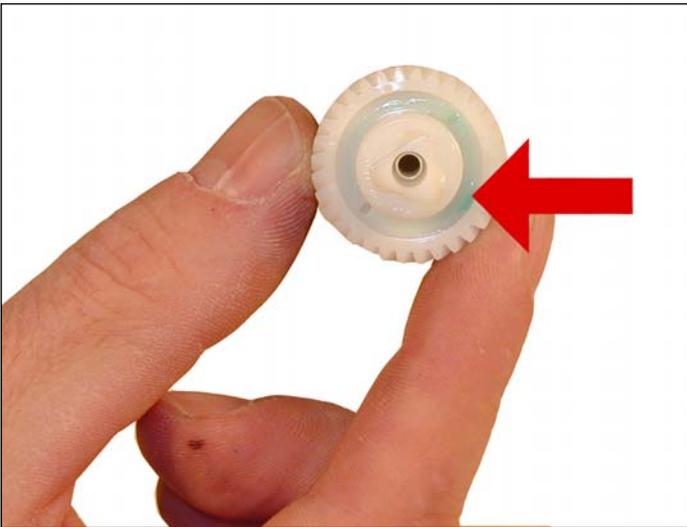
12. Re-Install the OPC drum and metal axle pin. The metal axle pin should have a good amount of conductive grease on the tip. Remove the old grease and replace before inserting the pin. Place a small amount of grease on the inside of the drive gear as indicated.

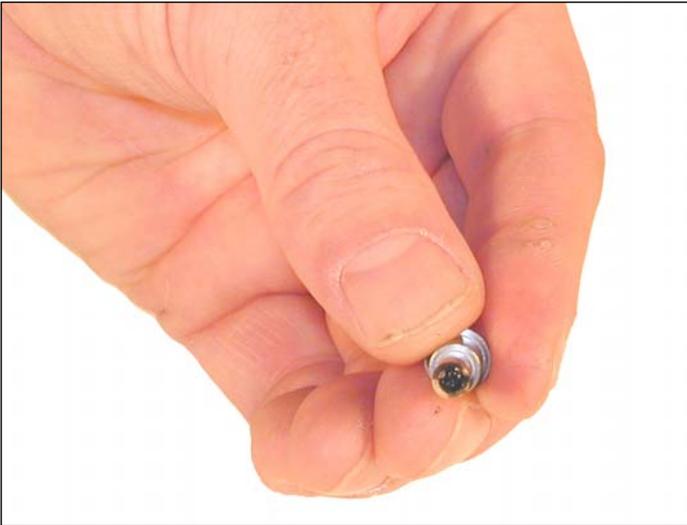
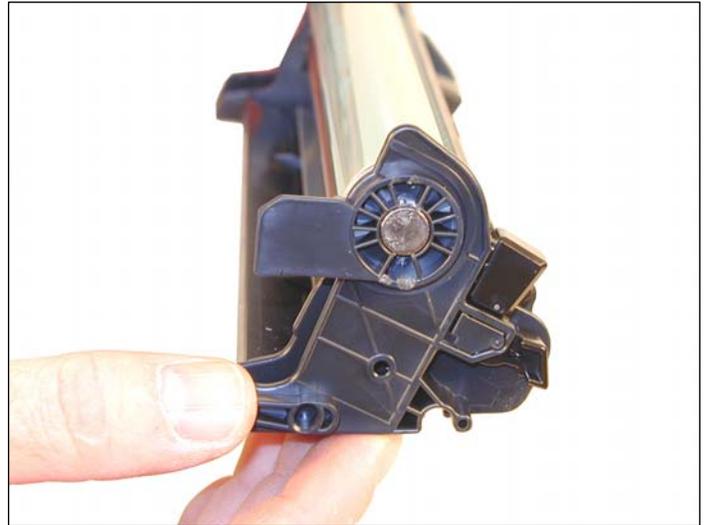
Make sure the axle pin is fully inserted.

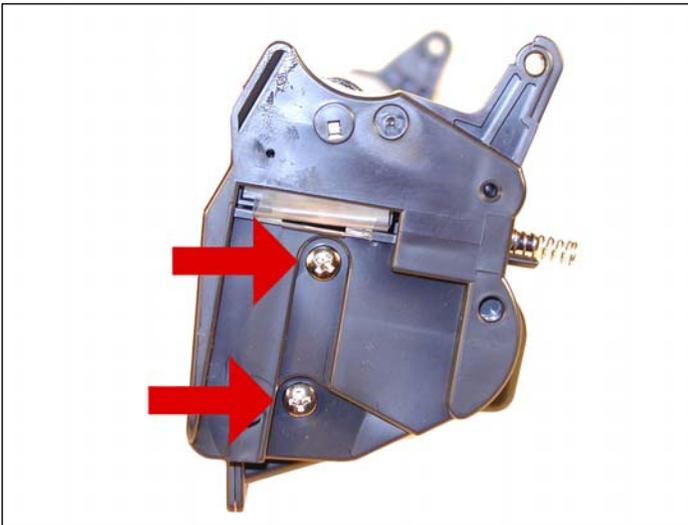
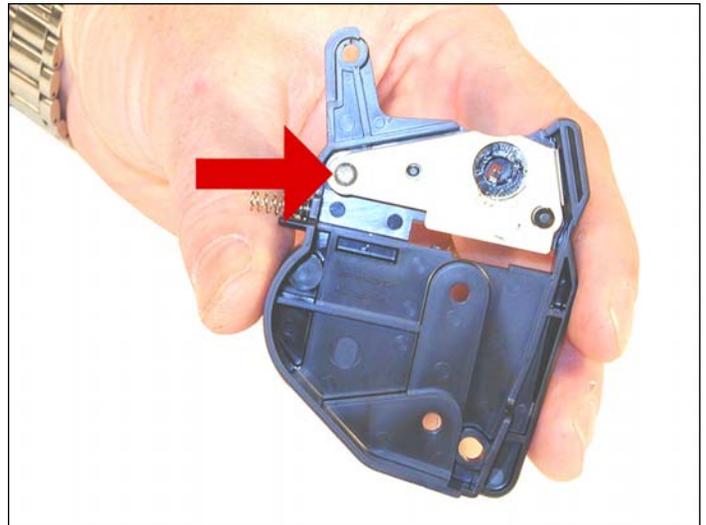
13. Remove the left side toner hopper end cap. Remove the two screws, and pry the end cap off.

The Mag roller bushing alignment pin will break.

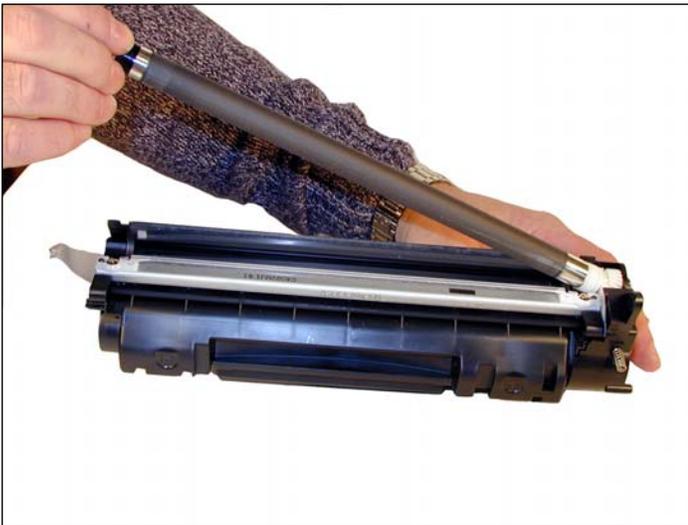
14. Remove the magnetic roller assembly.

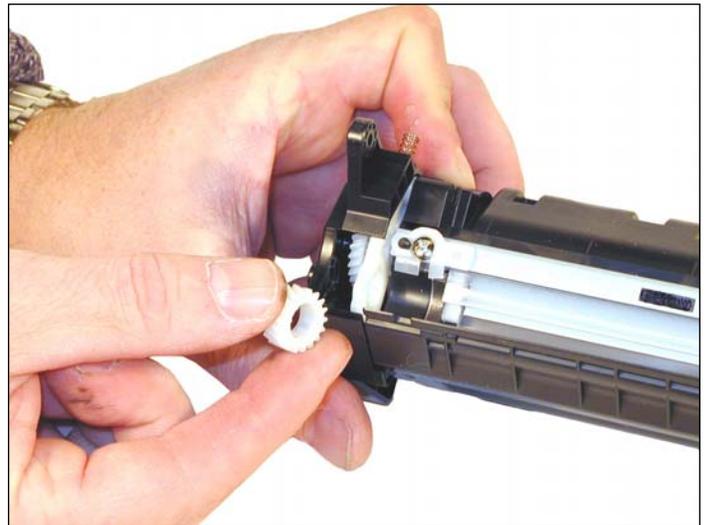
15. Remove the Magnetic roller drive gear and bushing if it did not come off with the roller.

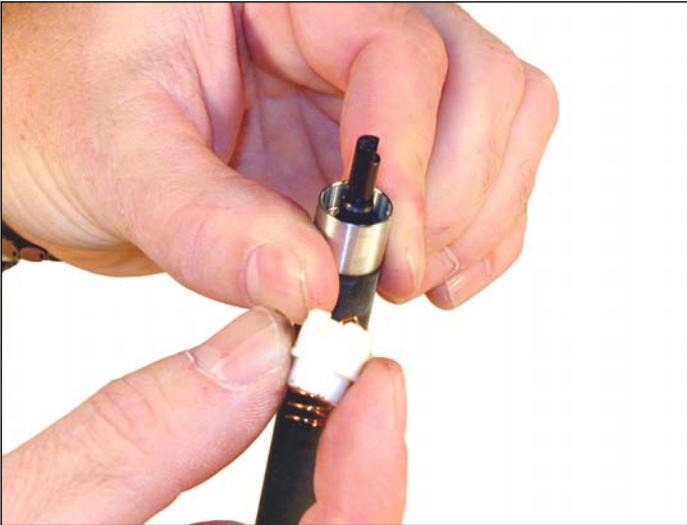
16. Replacing the magnetic roller sleeve is an easy task. Just press down on the stationary magnet and the plastic hub will pop out.

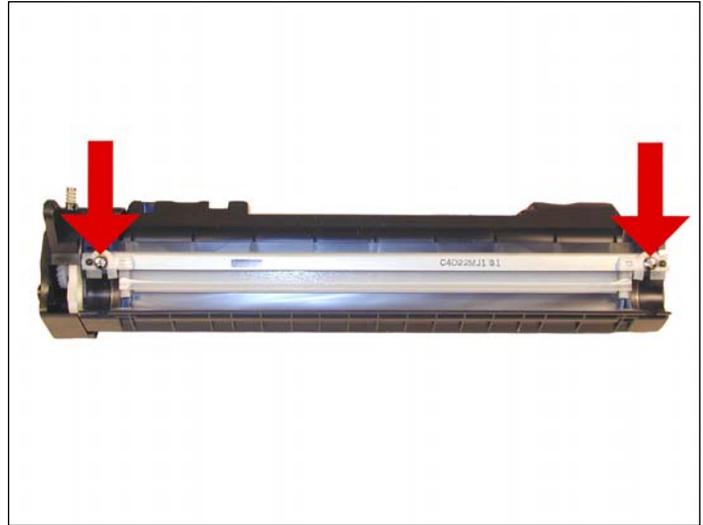
17. Remove the doctor blade and two screws.

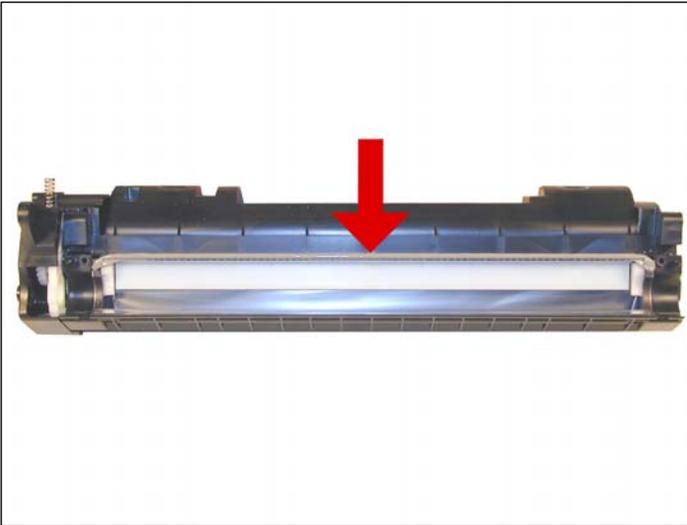
18. Clean out any remaining toner from the hopper. Note the doctor blade seal. It is a sticky substance that can be cleaned with alcohol if toner gets on it.

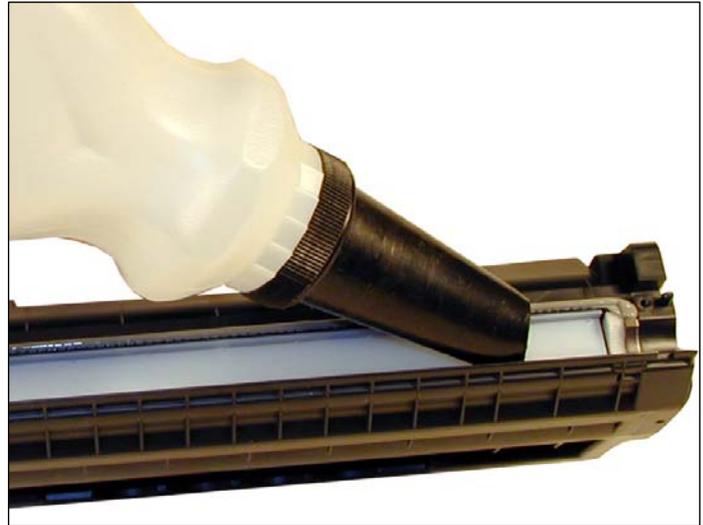
19. Fill through the Mag roller opening with the appropriate amount of 1320 toner for the "A" cartridge, and for the "X". There is no fill plug in these cartridges.

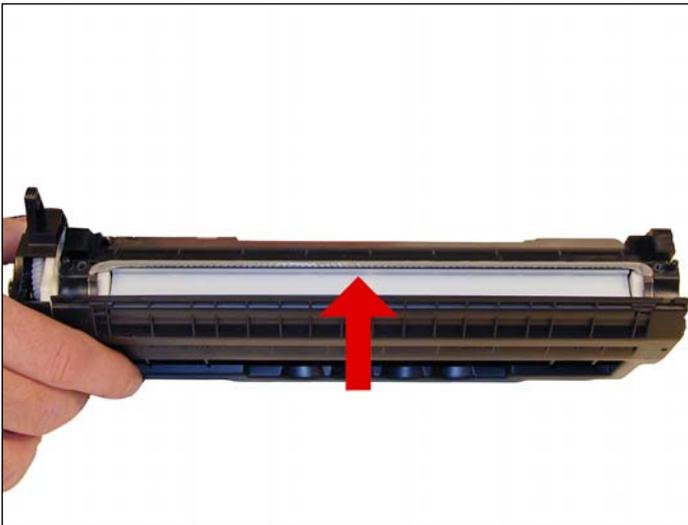
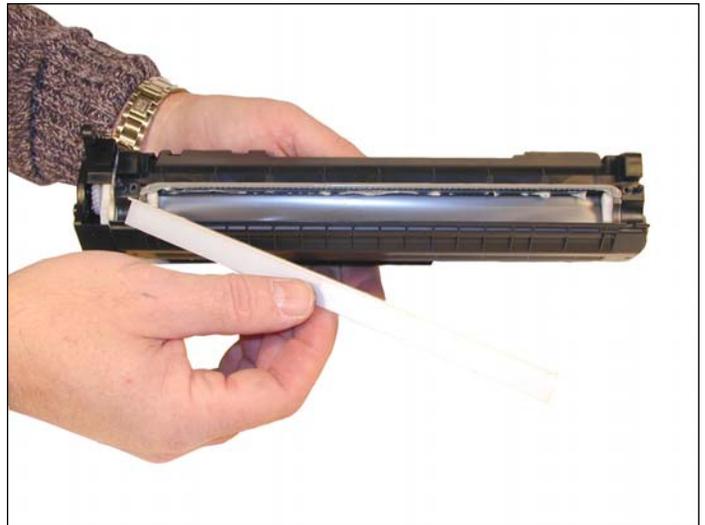
20. If you are going to seal the cartridge, there is a white plastic shelf that needs to be removed.

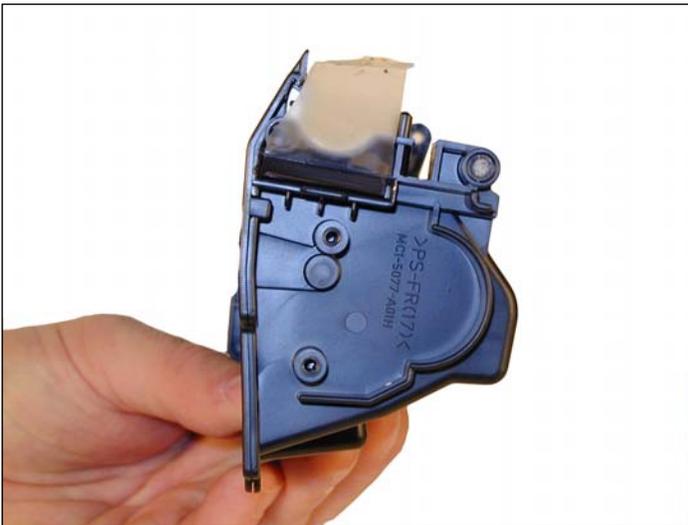
21. The shelf is held on with double sided tape. The seal tab fits through the right side of the cartridge (fill plug side). Shown is the seal exit slot.

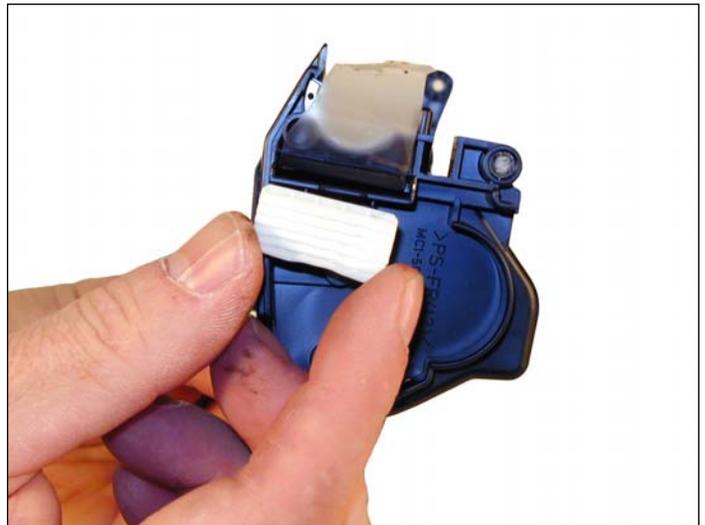
22. Close up is the port seal. Note that it is a rubber gasket that seals off the opening. This port seal must be removed before inserting a seal. Make sure it is put back or the cartridge will leak after the seal has been removed.

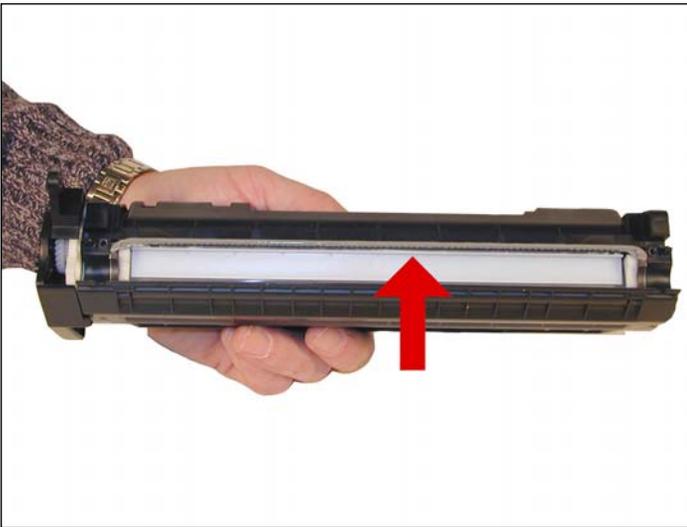
23. Re-install the white plastic shelf. If the adhesive is not working, replace it with a good double sided tape. This shelf in our first tests seems to help the flow of toner in the hopper.

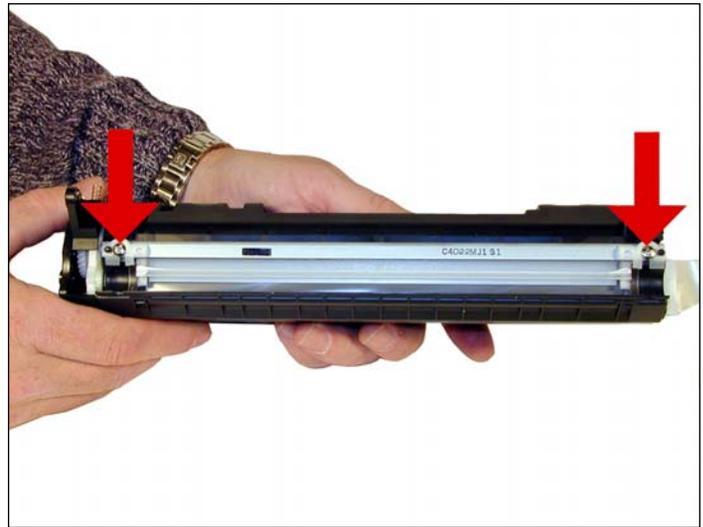
24. Re-install the doctor blade and two screws.

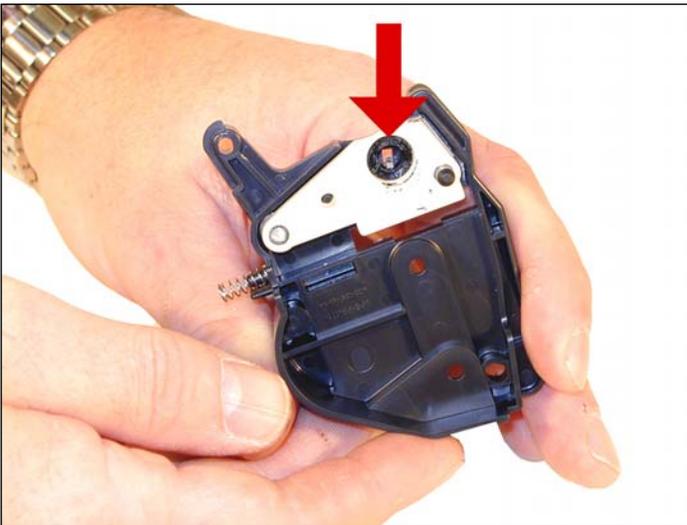
25. Clean the old grease off the contact plate and replace with new conductive grease.

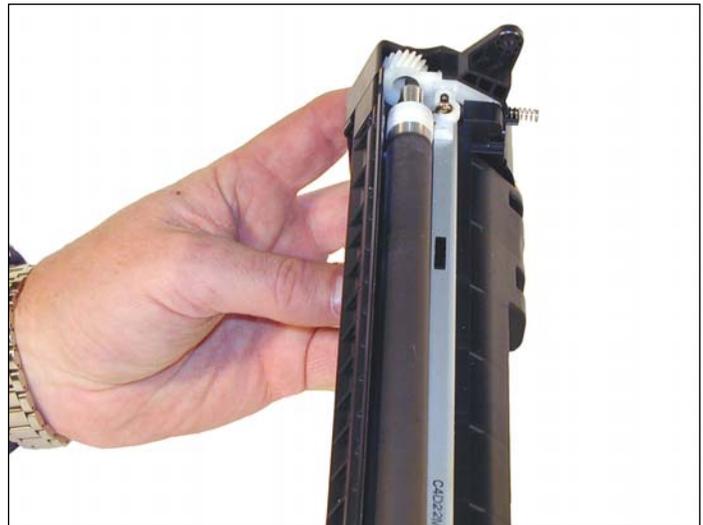
26. Re-assemble the toner hopper section. Place the Mag roller drive gear in place and install the magnetic roller assembly. Turn the roller until the keyed end fits into the drive gear properly. Install the end cap. Align the keyed magnet into the keyed slot on the gear side first. This will help in aligning the opposite end cap. At this time no new alignment pins are available. We have run the cartridges "as is" with no problems so far, but this will be a necessary part.

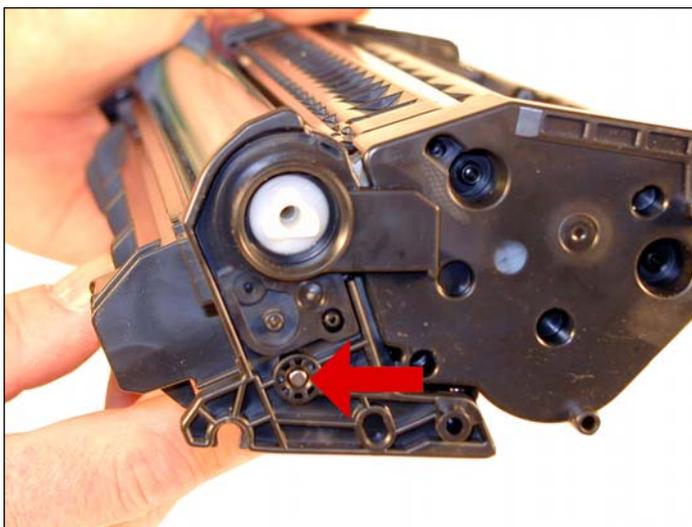
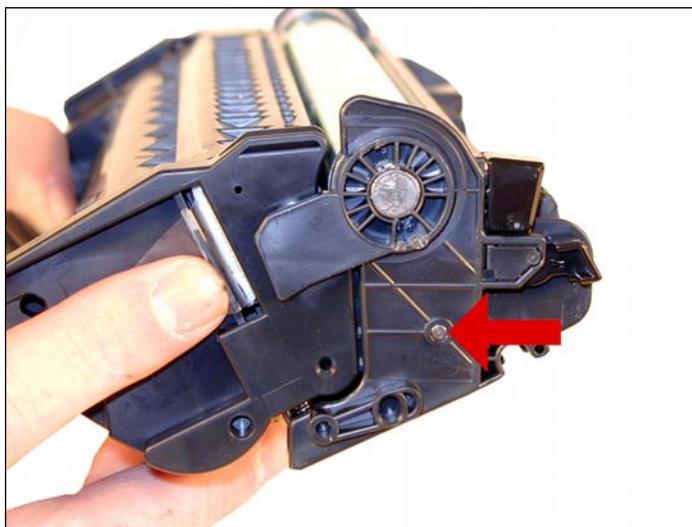
27. Place the two halves together. Make sure that the two springs are aligned and insert the two pins. Make sure that the pins are slightly pushed in so that they do not interfere with installing the cartridge in the printer.

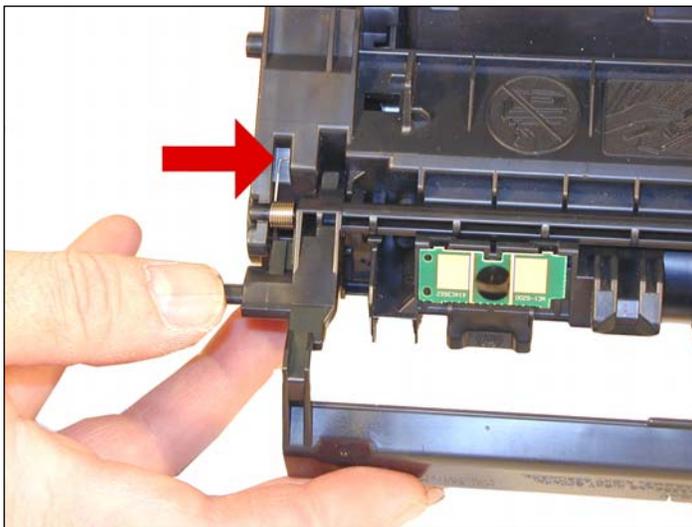
28. Install the drum cover. Make sure the spring is situated correctly.
